Rehabilitation and Repair

Lining system saves time in apartment building renovation

Unit helps pull new HDPE pipe through collapsed clay main

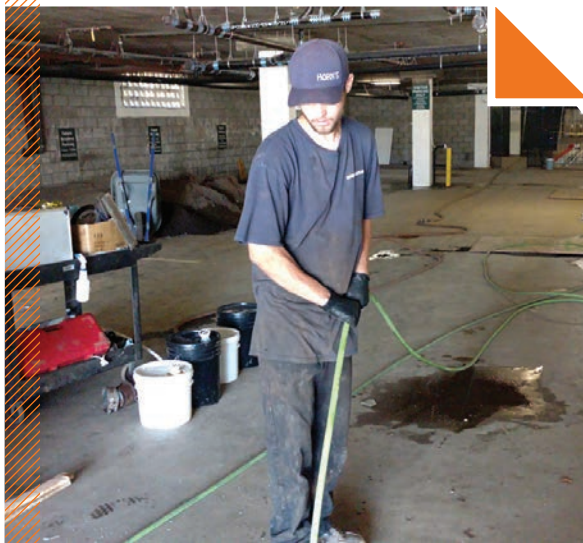
Problem: An old apartment building in Valencia, California, needed to be gutted and redone. The inspection of the plumbing system determined that the main drainpipe leading to the city sewer system out of the building was buried 5 feet below the concrete floor of the parking garage. While breaking the floor was an option, the cost of doing so was out of the budget. The 8-inch line ran the entire 110 feet of the structure.

Solution: Horn's Backflow and Plumbing Service selected the **Quik Shot** lining system supplied by **Pipe Lining Supply** to install the liner. They opened up an out-of-the-way location on the parking garage floor to use as their single access point for lining. To get in and out in a short amount of time, they elected to heat cure the liner after installation.

Result: Technicians spent less than a day to completely build a new pipe inside the form of the old sewer pipe. 888/354-6464; www.pipeliningssupply.com.

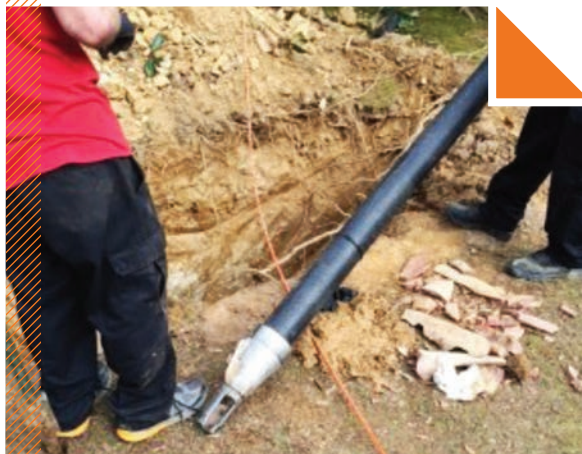
Problem: A residential customer in Germantown, Tennessee, was experiencing slow drains. Upon investigating, plumbers found extensive root infiltration in the home's main sewer line. They also discovered that the house had an old clay pipe that was collapsing and needed total replacement. Due to the condition of the pipe, relining was not an option. There were also several large, mature trees in the front of the home, coupled with a large landscaped berm forming a natural water barrier. Traditional approaches to trenching and replacing the sewer pipe were not possible.

Solution: The **Spartan UnderTaker** flawlessly pulled the new pipe through the old clay pipe — something that would have been nearly impossible without the proper equipment. In less than three hours, over 90 feet of failing clay sewer main was replaced with a new 4-inch HDPE pipe.

Result: The unit helped the homeowner avoid thousands of dollars in landscaping repairs. The home's occupants continued to use their sinks, showers and bathroom as the plumbing techs performed repairs on the line. While this was great for the homeowners, it is also a fit for commercial properties, such as supermarkets, where a complete closure would mean the loss of revenue. 800/435-3866; www.spartantool.com.
